Highways Rebuttal to PoE

CHURCHFIELDS ROAD DEPOT, CHURCHFIELDS ROAD, BECKENHAM

Existing Site Access onto Churchfields Road

Road Safety Assessment
Requested by SLR Consulting

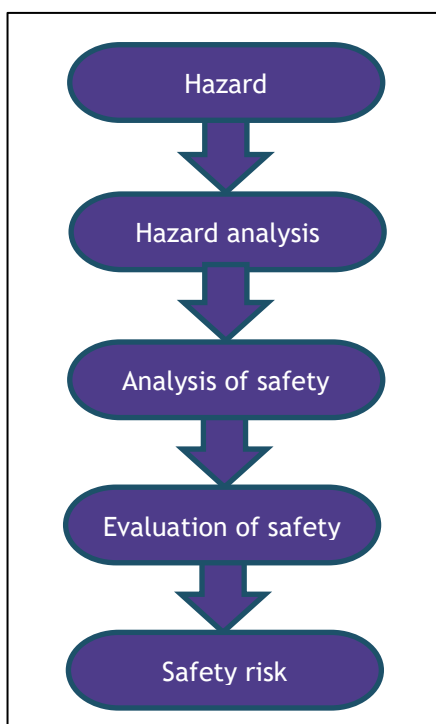
- 3.5 An alternative road safety risk assessment methodology that is more directly linked to road safety risk assessment is provided by GG104 (DMRB). The suggested safety risk assessment planning process is summarised in **Figure 4**.

Figure 4: GG104 Safety risk assessment planning process
